# Internal Correspondence

AVO 11-F1-1038

Re: S-92 T/R Pitch Beam Locking Washer and Nut Installation Test

Dt: February 3, 2011

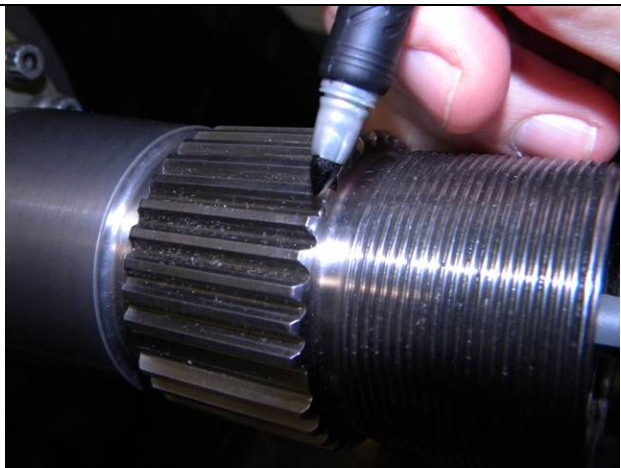
Pitch Change Shaft Pre-Test Damaged Tooth

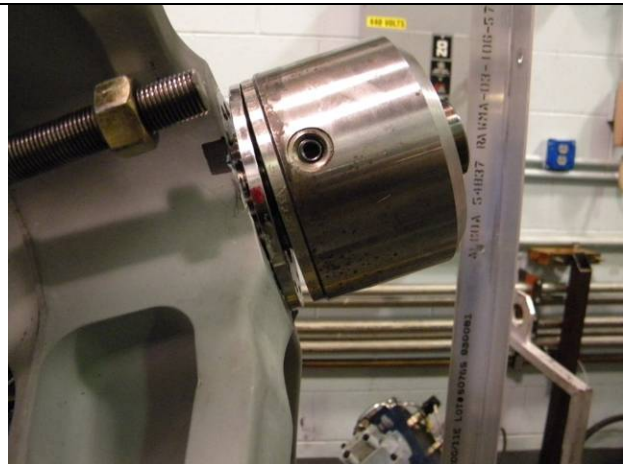
With CA1000 applied to all mating surfaces of the locking washer, it was markedly simple to cause a misalignment of the locking washer on the spline and have it partially engage the shaft teeth as the retention nut was rotated and tightened. With the locking washer misaligned, it turned approximately 90° clockwise as the retention nut was being preloaded. At that point (less than 10 ft\*lbs torque), the locking washer partially engaged the spline teeth and remained in the cocked condition until the full 202 ft\*lbs of torque were achieved. The gaps created by the cocked condition were easily visible (and measureable) and can be referenced in an added Engineering safety procedure, if necessary. The post-test condition of the teeth on the locking washer included barely visible evidence of the misalignment against the shaft splines. However, the test damage did not include the same deformation of the shaft splines that was apparent on the incident aircraft due to the dynamic forces present. The recommended safety procedures realized during this test are included in the latest revision of Engineering Instruction (EI) E92-725-10-136.

Locking Washer Misaligned on Shaft Spline

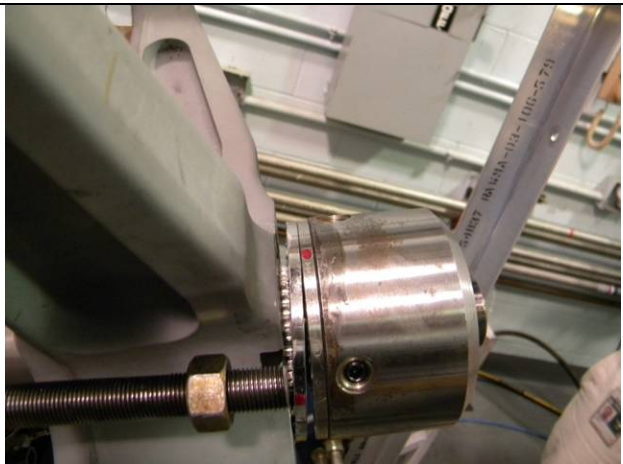
Retention Nut Incorrectly Installed, 0 ft\*lbs

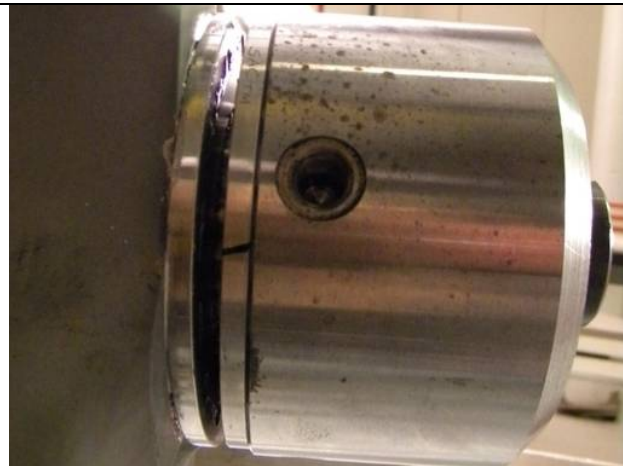
13. Record the height of the protruding shaft threads here: -0.030" (negative threads)  
 14. Record the maximum height of the gap between the locking washer and the pitch beam face here: 0.121"  
 15. Remove retention nut, locking washer and pitch beam for inspection of spline damage. Clean parts with alcohol wipes to remove CA1000 prior to taking post-test photographs.  
 16. Return all test parts to Materials Lab and Engineering for further analysis.

Locking Washer / Retention Nut Gap

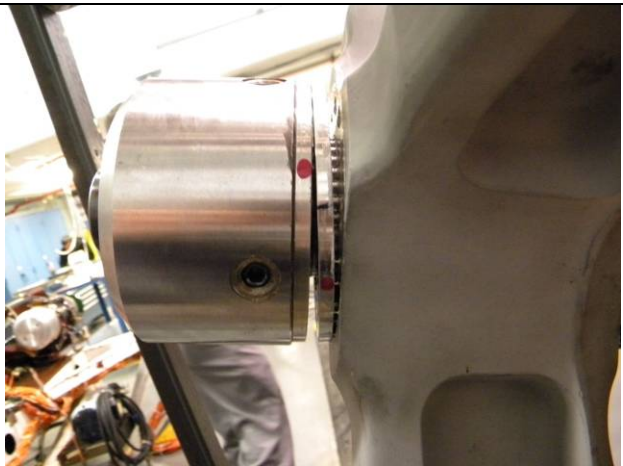
Locking Washer Cocked Condition on Spline

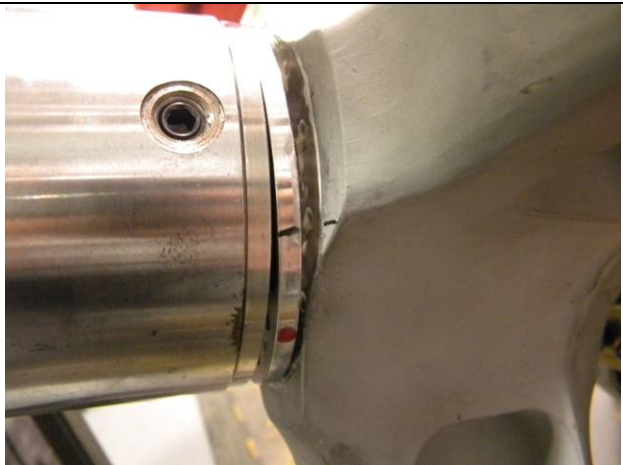
Misalignment at 60 ft\*lbs

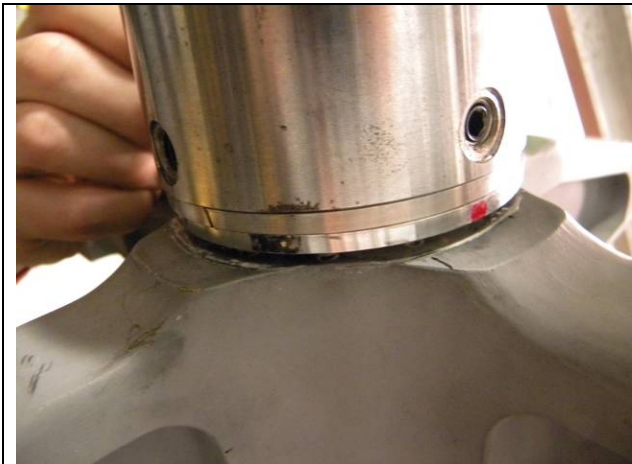
Misalignment at 120 ft\*lbs

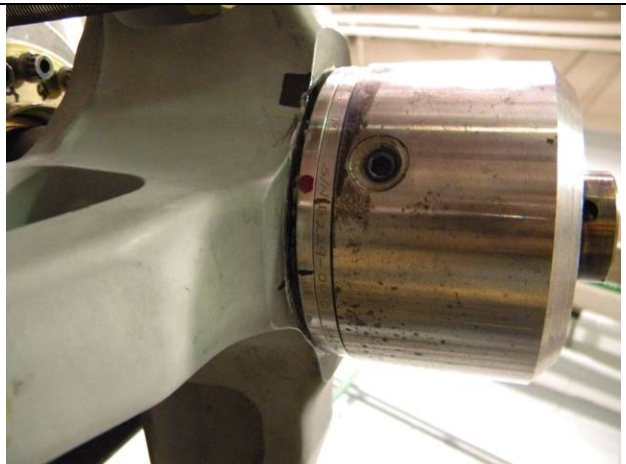
Misalignment at 183 ft\*lbs

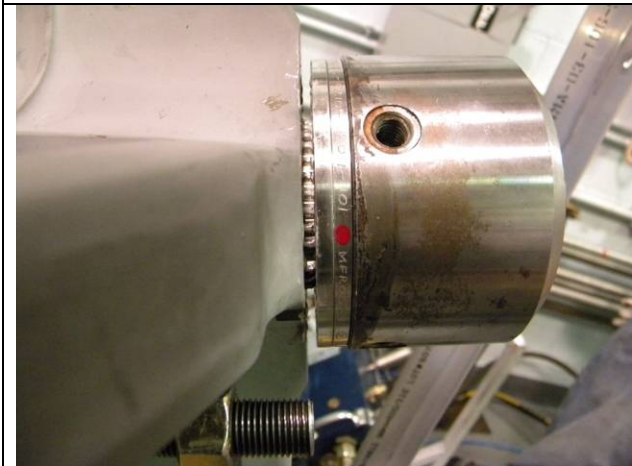
Misalignment at 183 ft\*lbs

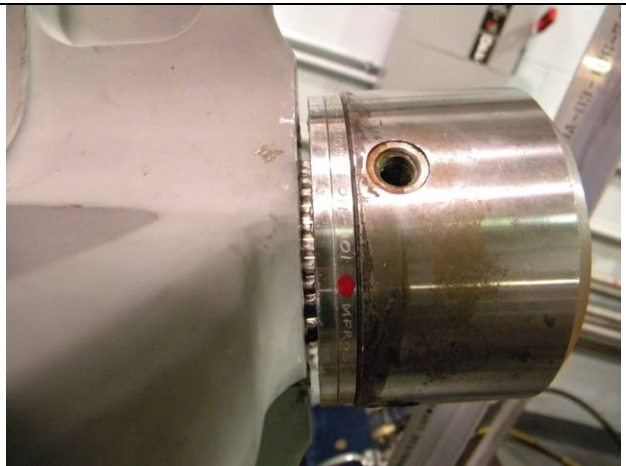
Misalignment at 202 ft\*lbs

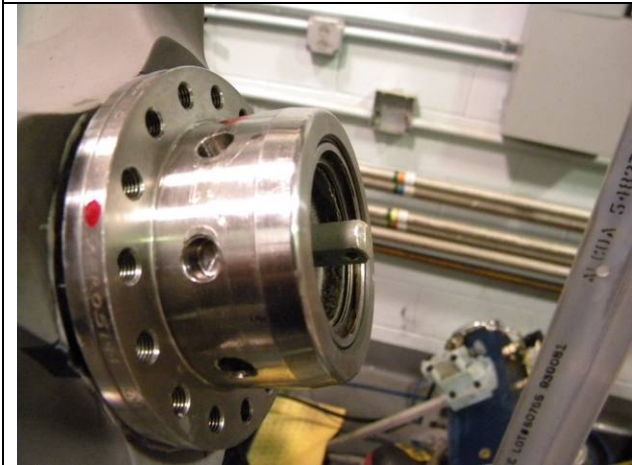
Misalignment at 202 ft\*lbs W/O Tool on Nut

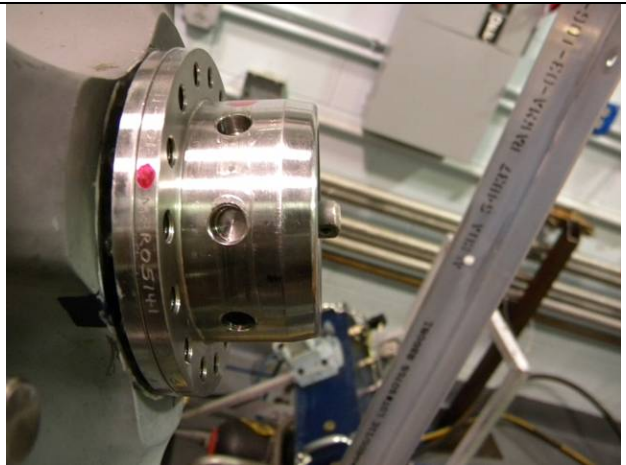
Incorrect Complete Installation, 202 ft\*lbs

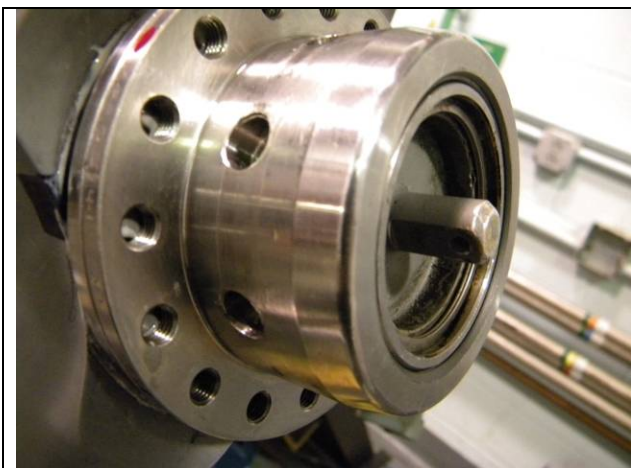
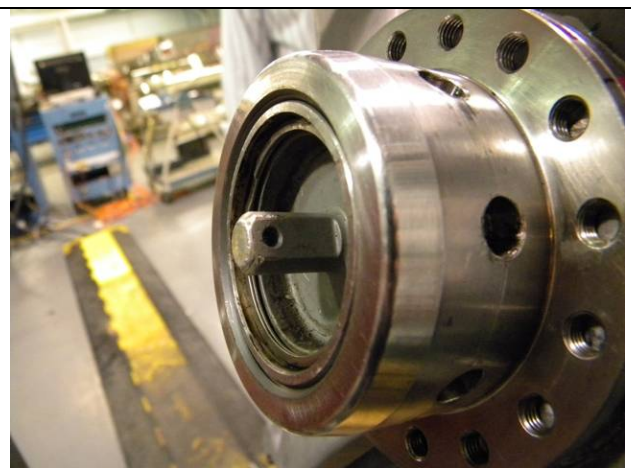
Negative Thread Protrusion, 202 ft\*lbs
